E. E. S. REPORT C-3599-A(1)  
25 MARCH 1949

UNITED STATES NAVAL  
ENGINEERING EXPERIMENT STATION

PHILIPS MODEL 1/4D EXTERNAL COMBUSTION ENGINE

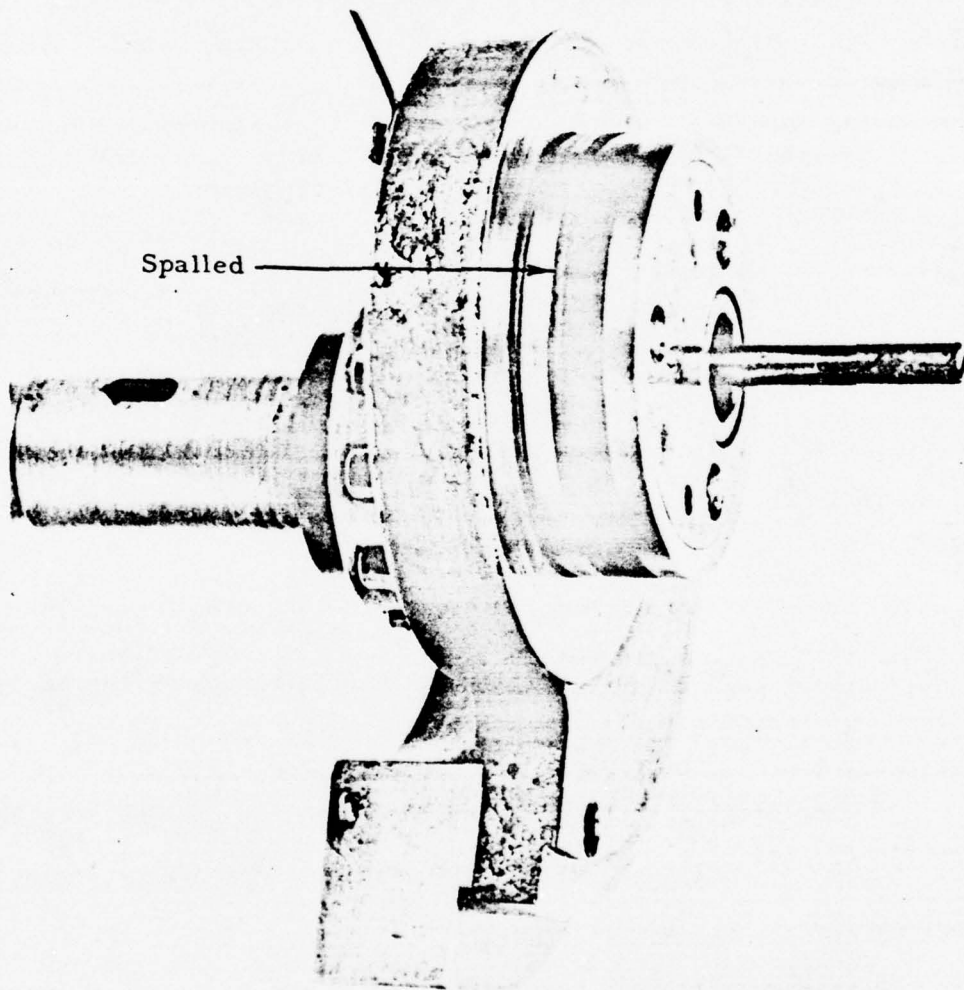
PLATE 2

- (a) The inner race of the crankpin needle bearing was spalled near the edge of the bearing roller travel, Plate 2. The bearing race was replaced by the contractor before re-assembly of the engine.
- (b) The lower end of the cylinder, below the ports, had a scuffed appearance, Plate 3. The damage was not sufficient to indicate the probability of piston seizure.

CRANKSHAFT OF ORIGINAL ENGINE, PRE-TRIAL INSPECTION,  
SHOWING SPALLED SURFACE OF CRANKPIN

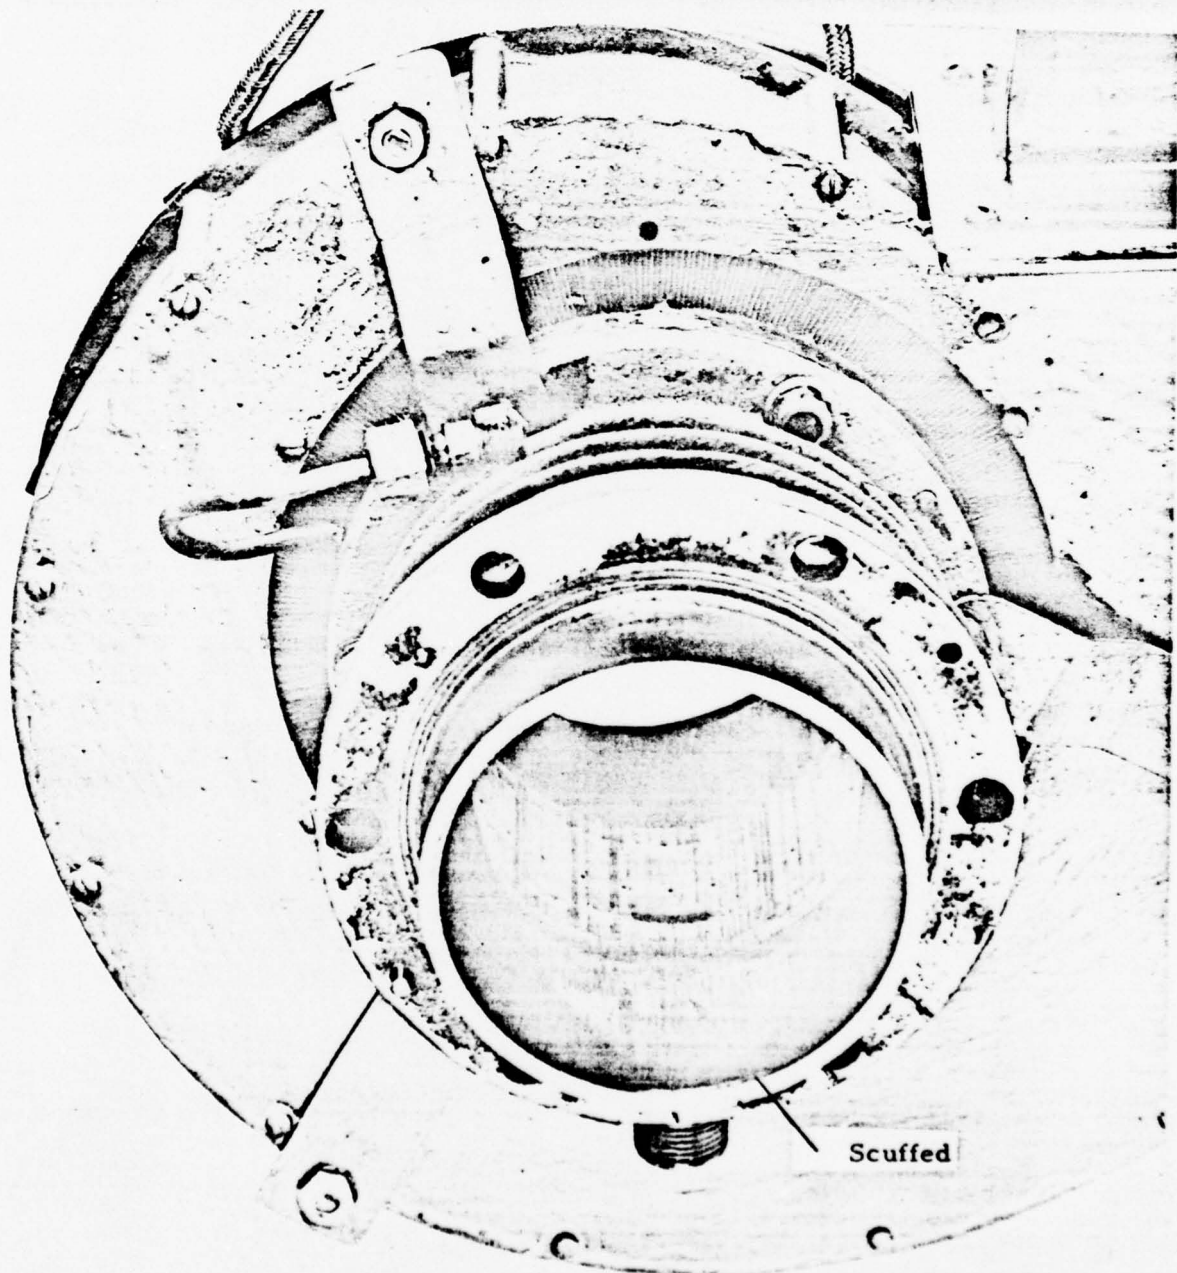
LOWER END OF CYLINDER, PRE-TRIAL INSPECTION  
ORIGINAL ENGINE

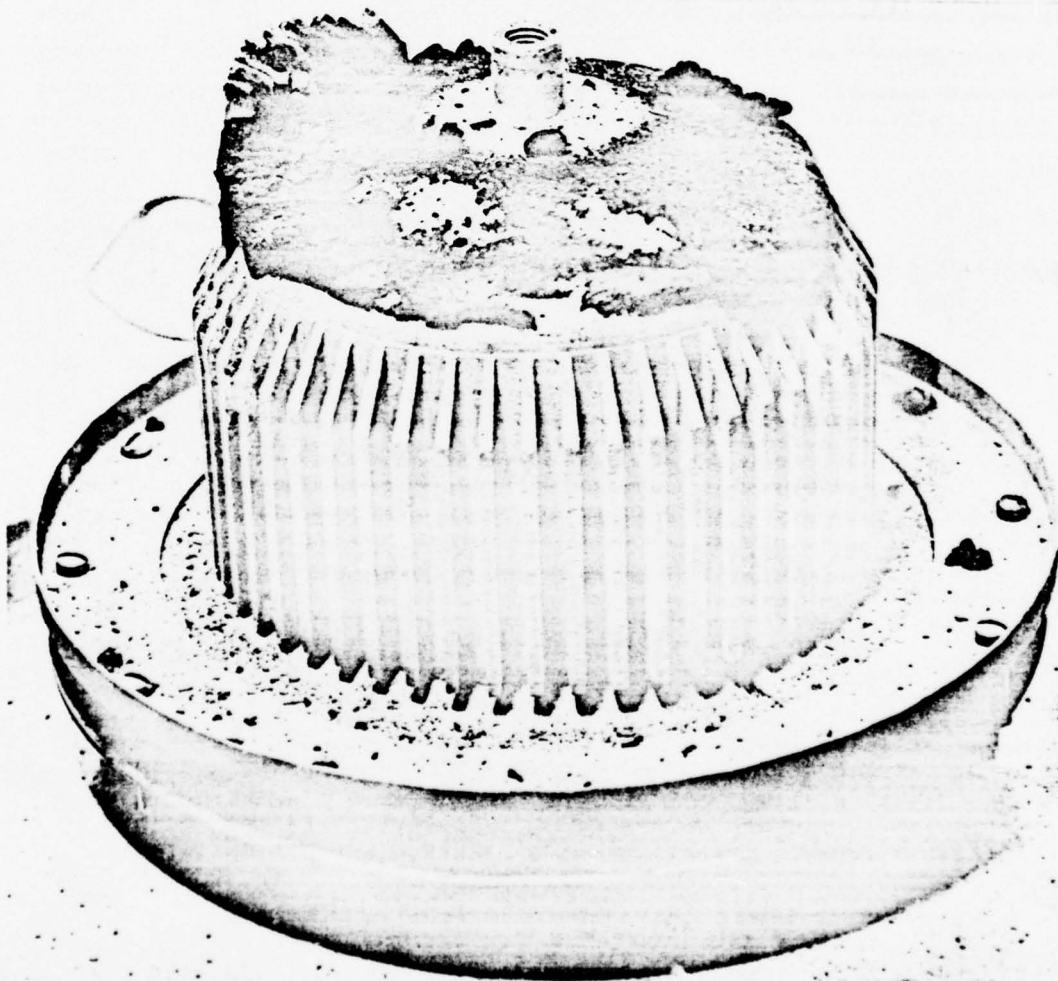
PLATE 6

- (c) Throughout the test, the engine was usually difficult to start, requiring from two to ten trials.
- (d) On two occasions, heavy carbon deposits were found on the heater head, Plate 6, causing interference with combustion.

26. It is considered probable that the observed carbon deposits on the heater head were caused by minor combustion derangements. The deposits occurred at irregular intervals and on some occasions they followed observed combustion irregularities. It is considered that the range of acceptable combustion conditions is too narrow and that the combustion is excessively sensitive to various factors such as burner nozzle pressure, partial plugging of fuel or air nozzles, and variation of the fuel nozzle suction lift.

CARBON FORMATION ON HEATER HEAD, ORIGINAL ENGINE  
4-1/2 HOURS OPERATION SINCE CLEANING

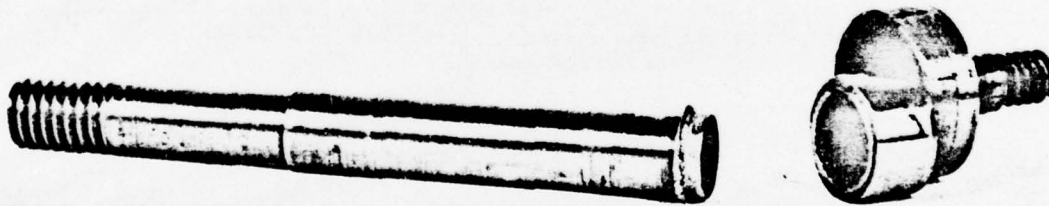
PLATE 8

- (e) Compressor difficulties included: cracking of two suction valve discs, Plate 7; sticking of the compressor piston; fouling of the discharge valve with carbon deposits; loosening of the suction valve neoprene seat; and breakage of the compressor crankshaft by failure of the brazed joint of the two-piece shaft, Plate 8.

29. The breakage of the compressor crankshaft, Plate 8, was caused by the compressor piston striking the head during operation as a result of insufficient adjusted clearance. A weak brazed, two-piece construction of the crankshaft contributed to the failure. The crankshaft was later replaced by a one-piece shaft of increased strength.

BROKEN COMPRESSOR CRANKSHAFT, ORIGINAL ENGINE

61 HOURS OPERATION

| Eng.<br>Hrs. | Casualty<br>or Operating Difficulty | Cause | Action Taken |
|---|--|--|--|
| 61 | Compressor not delivering air. | Compressor crankshaft broken, Plate 8. Suction valve neoprene seat loose. | Repaired compressor crankshaft; installed new compressor head with beryllium-copper suction valve disc. |

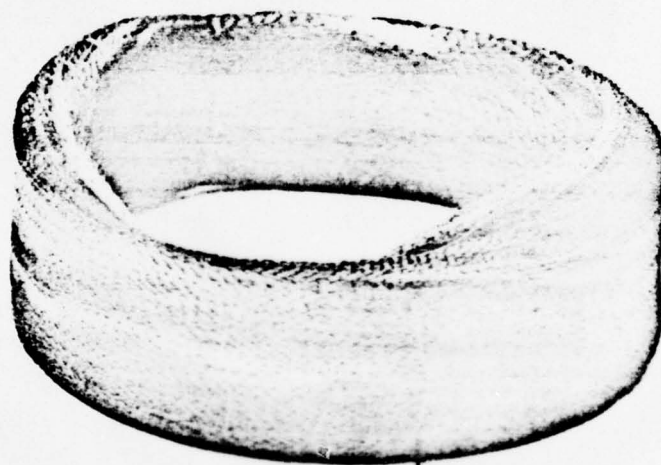
- (i) In the inspection of the engine, incident to the replacement of the heater head, black and white deposits were found on the metal wire of the regenerator, Plate 9. The results of a chemical analysis of the deposits indicated that they contained oil and corrosion or wear products of steel and copper materials in the engine, Appendix III.

33. The analysis of deposits found on the regenerator of the original engine after 81 hours operation, Plate 9 and Appendix III, suggests that corrosion and/or wear products of iron or steel and copper formed part of the material. Analysis of crankcase lubricating oil removed from the engines, Plates 10 and 17, show extraordinarily high ash content for a straight mineral oil, 0.14 to 0.45 percent, indicating the presence of unusual amounts of wear products.

REGENERATOR, ORIGINAL ENGINE  
81 HOURS OPERATION

Discolored by Deposits

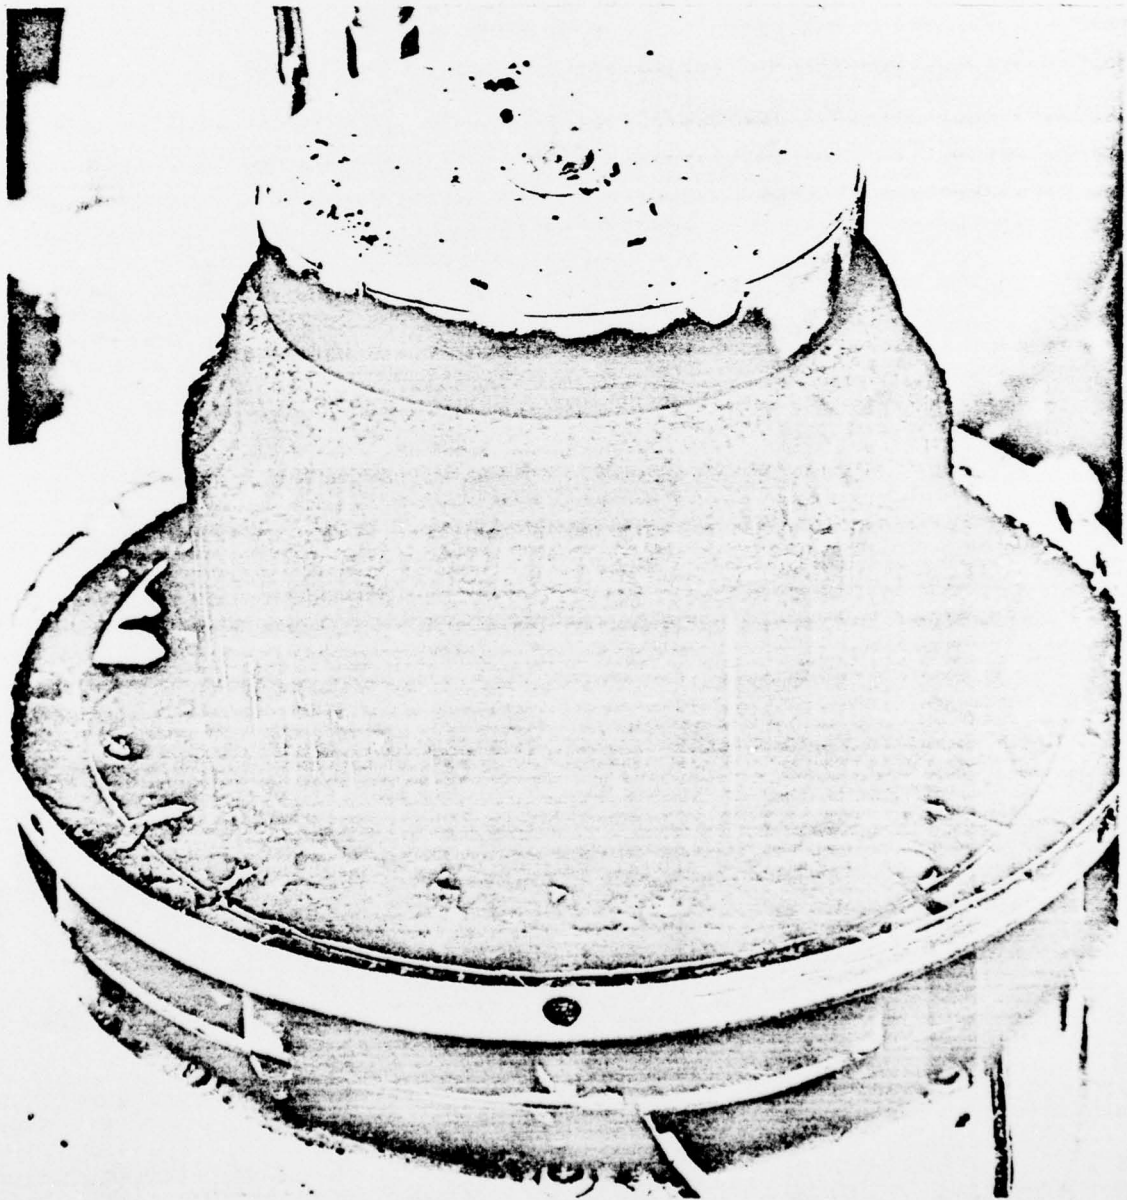
- (a) On three occasions, partial plugging of the gasoline and/or air nozzles occurred, causing the temperature of the heater head to be reduced.
- (b) On three occasions, carbon deposits on the heater head and related parts, Plates 14 and 15, caused a reduction in the heater head temperature.

CARBON FORMATION ON HEATER HEAD, REPLACEMENT ENGINE  
12 HOURS OPERATION SINCE CLEANING

| Eng. Hrs. | Casualty or Operating Difficulty | Cause | Action Taken |
|---|---|--|---|
| 12 | Low heater head temp. | Carbon deposits on heater and burner heads, Plates 14 & 15. Burner grate deformed, Plate 16. | Removed fuel measuring equipment and modified tubing so engine operated directly from self-contained fuel tank. Cleaned heater and burner heads. Straightened burner grate. |

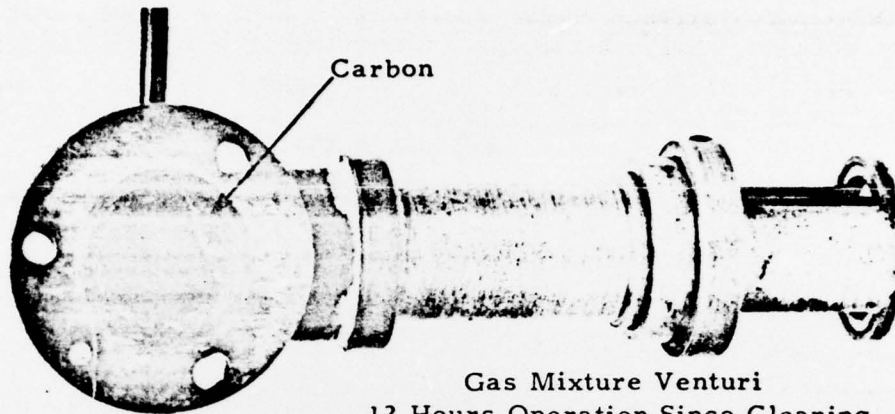
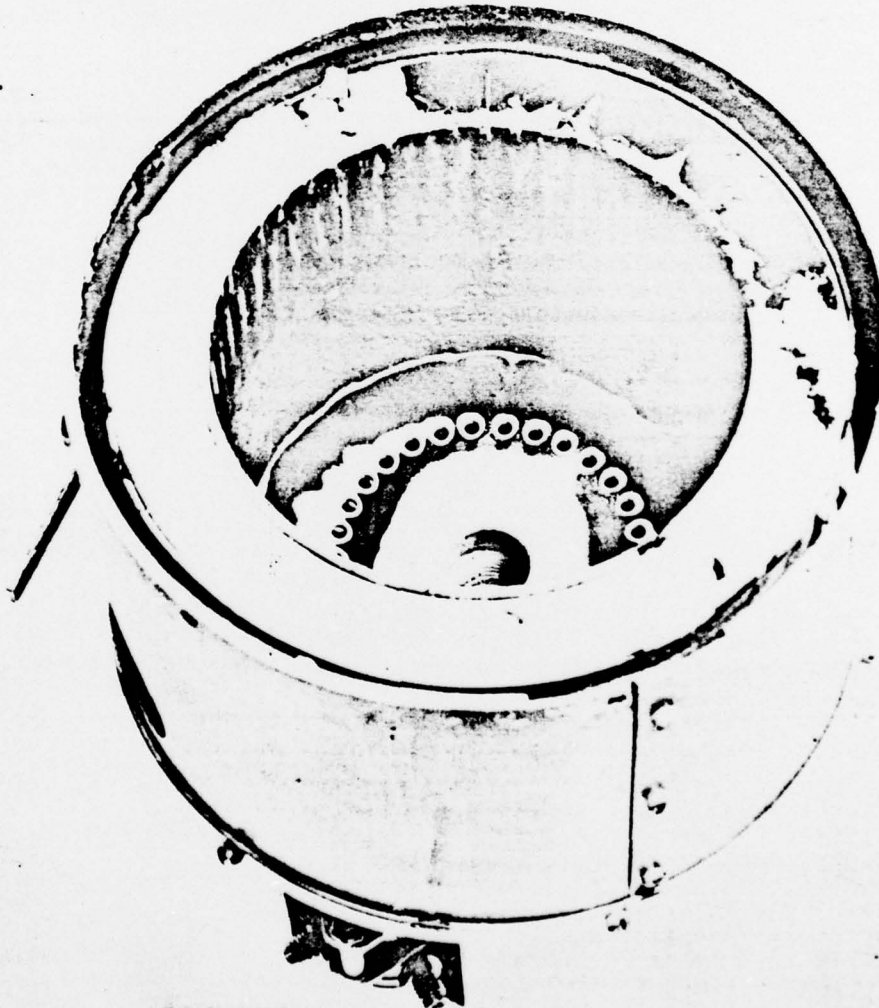
Gas Mixture Venturi  
12 Hours Operation Since Cleaning

Carbon Formation in Burner Head, Replacement Engine  
12 Hours Operation Since Cleaning

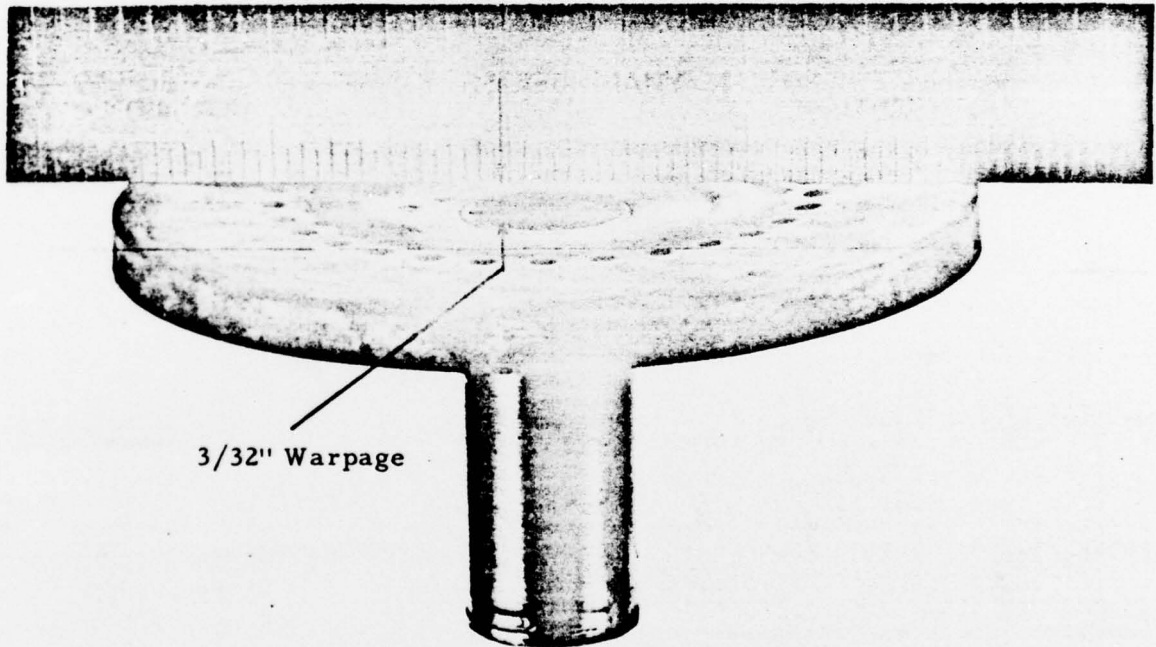
- (e) After 12 hours operation of the engine, deformation of the burner grate occurred, Plate 16, resulting in improper combustion. The part was replaced by a re-designed part having a tapered section; there was no further similar difficulty during the remainder of the test operation.

38. The deformation of the burner grate of the replacement engine after 12 hours operation, Plate 16, was caused by the inadequate design of this part. The grate was supported only at its center and it operated at substantially red heat. The replacement grate had a thicker section at its center with the section tapering toward the periphery. This grate appeared to perform satisfactorily, without visible distortion, during the remaining 67 hours operation.

BURNER GRATE - REPLACEMENT ENGINE  
12 HOURS OPERATION

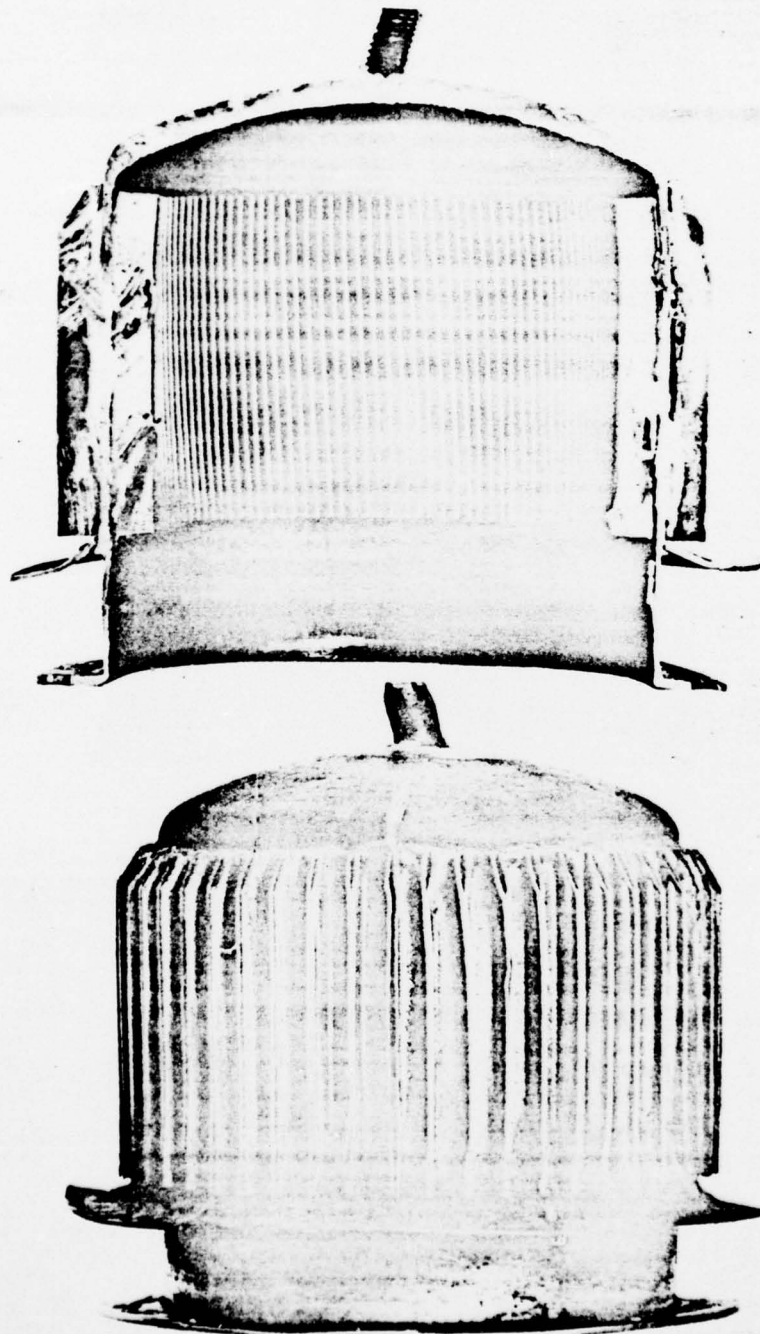
- (h) Cracking of the heater head occurred after 77 hours operation, resulting in a loss of air pressure. The results of a metallurgical examination of the failed part are given in Appendix II.

3. The photographs shown on page 3 illustrate the appearance of the head as received. A photomicrograph (X7) of a polished and etched section through the failure is shown on page 4. Details of construction are clearly evident, and the main crack was found to be surrounded by secondary cracks. Subsequent sectioning and dismantling revealed the crack to be about 1-1/4" long, extending to within 5/16" of either end of the fins.

METALLURGICAL EXAMINATION OF  
CRACKED HEATER HEAD OF ORIGINAL ENGINE

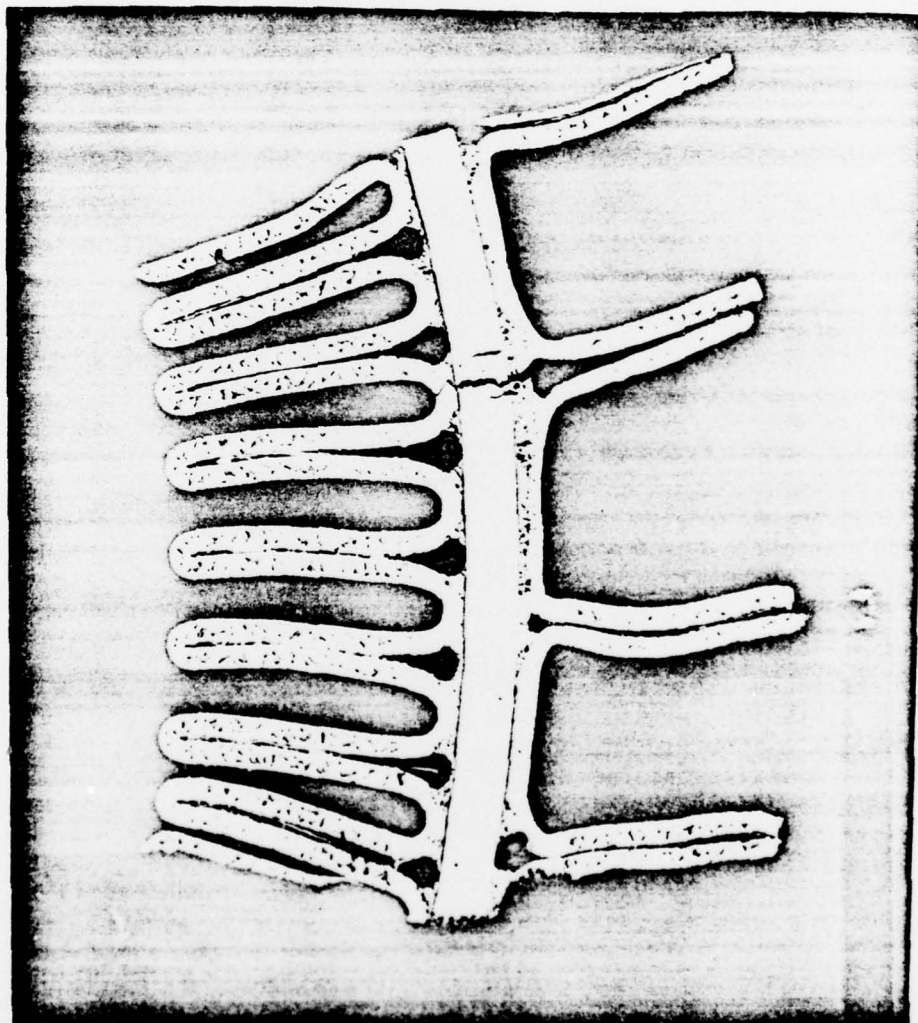
X 7

METALLURGICAL EXAMINATION OF  
CRACKED HEATER HEAD, ORIGINAL ENGINE

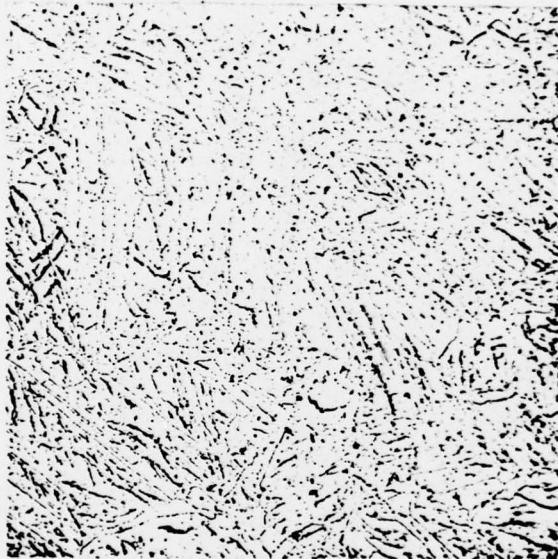
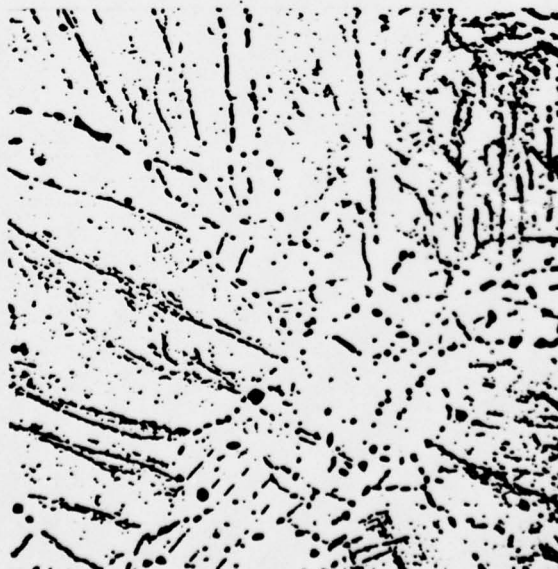
4. The microstructure of the stainless shell is shown on page 5. The structure consisted of coarse grained austenite containing many twins. Carbides were precipitated at the grain boundaries and twin planes. The structure is not unusual for this type of material. The bond between the shell and fins was found to be strong.

METALLURGICAL EXAMINATION OF  
CRACKED HEATER HEAD, ORIGINAL ENGINE

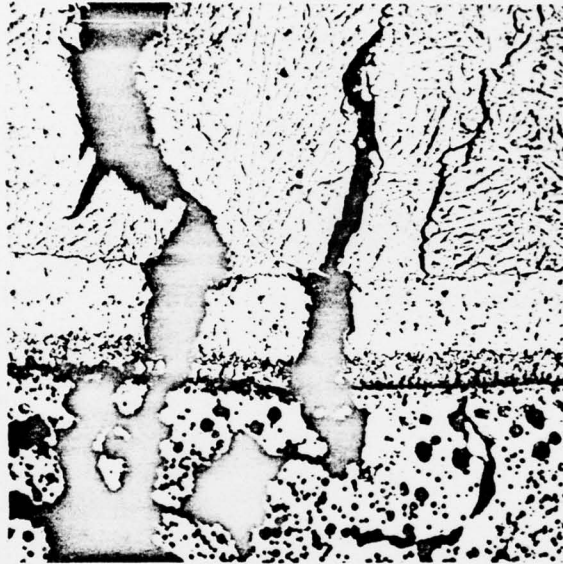
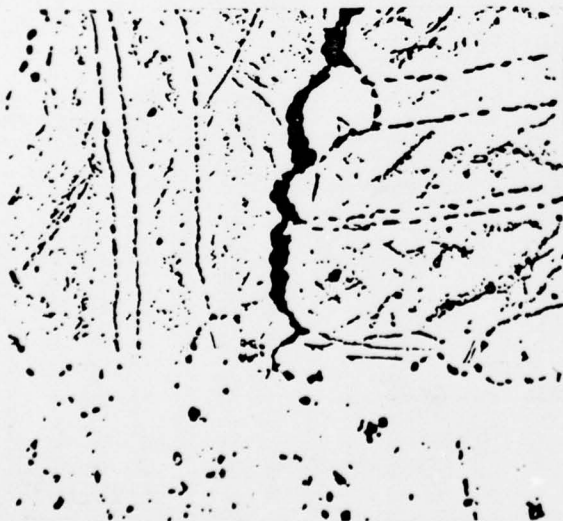
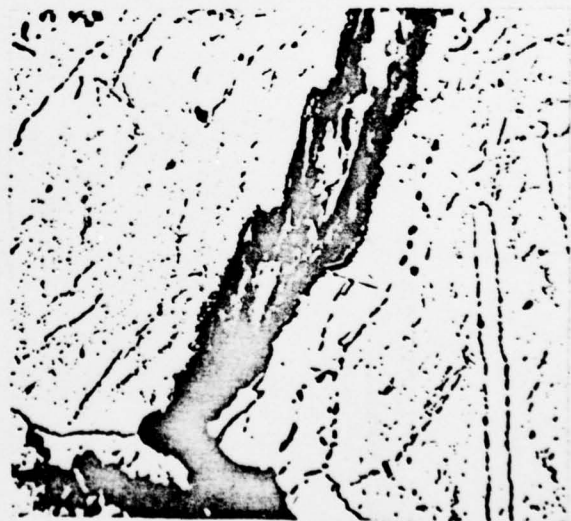
6. Photomicrographs taken in the cracked areas are shown on Page 6. All of the cracks followed intergranular paths and contained foreign matter which may be oxides of steel or penetration of brazing alloy oxides. However, for the reason stated in the previous paragraph, if the foreign matter is brazing alloy residue, it is believed that the penetration did not occur until after the crack had formed. The photomicrographs seem particularly interesting since the three cracks illustrated show the life history in the crack development. It is especially noteworthy that the cracks start in the steel shell, then subsequently open up through the brazing alloy and bronze fins to produce a leak.

7. The intergranular nature of the attack and the complete lack of ductility around the rupture would indicate that creep at elevated temperatures was the cause of the failure. The development of an intergranular crack then could be accelerated by the presence of liquid brazing compound. The possibility of a crack formed during fabrication of the shell, even before service, should also be considered, particularly since reference (b) states "X-ray examination of three shells as machined, before brazing the fins in place, located a vertical crack about 5/16" high in one head."

METALLURGICAL EXAMINATION OF  
CRACKED HEATER HEAD, ORIGINAL ENGINE
